**Flood Control Project Maintenance
Levee Inspections**
LMA District Cover Sheet
Spring 2017 Levee Inspection Results

American River Flood Control District

Spring 2017 Levee Inspection Results

Waterway			Bank	Unit Miles
Unit No. 01 Arcade Creek			Left	2.08
	Spring (March - May)	Summer (June - August)	(September - November) Fall	Winter (December - February)
Unit Maintenance Rating (Fall Only)				
Date of Inspection	3/15/2017 - 5/3/2017			
DWR Inspector	Maksim Khashchuk			
Accompanied By	Ross Kawamura ARFCD

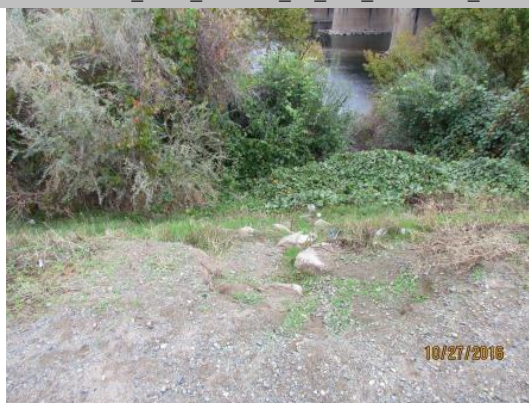
Photo 1 of 2 : SP_2017_NA0001_55_250_20170313_00190.jpg

LM Start	1.85	Rating **	A/W	Issue No.	250
LM End	1.85	Issue Type +	Ma	Location *	WS
Category	Earthen Levee			GPS Latitude/Longitude	
				Start	End
Item	Slope Stability			38.596220 °	38.596220 °
				-121.477713 °	-121.477713 °
DWR ID	DWR_NA0001_04_s_2016_250				
Comment Code					
S2 : Repair the levee slope damaged by foot traffic and prevent access where possible.					
Inspector Comment					
The erosion of the levee slope from the footpath appears to be stable at this time and should be monitored.

View of the footpath on the waterside levee slope, looking at the slope.

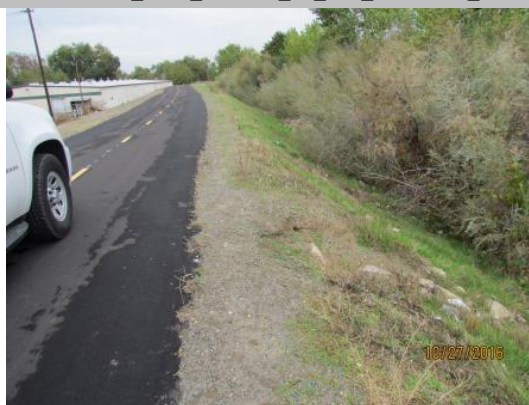
Photo 2 of 2 : SP_2017_NA0001_55_250_20170313_00191.jpg

View of the footpath on the waterside levee slope, looking downstream.

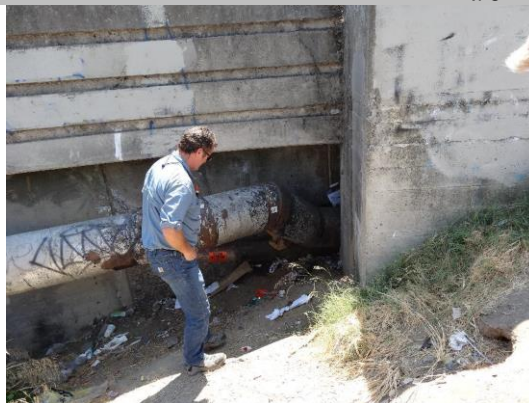
Photo 3 of 3 : UCIP_SP_2017_49935_75833.jpg

Item	DWR UCIP Field Study			38.595911 °		38.595911 °
				-121.477485 °		-121.477485 °
DWR ID						
Comment Code						
Inspector Comment						
FS_ID:49935 DS_ID:24307 EP_NO: N/A Repair Type: Urgent Crossing Status: Found UCIP Comments: 8/11/2016 Crossing was classified incorrectly. Crossing is not a gas line. This crossing appears to be an abandoned sewer line. On WS, holes are present on the pipe wall and visible cracks are found on the concrete wall where pipe crosses. According to LMA, Tim Kerr and Richard Marck, this crossing could be a City line. Need to find owner and determine fate of crossing. Owner will need to coordinate with CVFPB to comply with Title 23. (DWR UCIP - omagana)12/19/2013 No markers or labels visible to indicate line is gas line--unable to confirm. (DWR UCIP - omagana) FIELD_STRUCT_DESC: *ABANDONED* 18-inch (not 20-inch as referenced in DWR levee logs) steel line of unknown type through the levee, 5 feet below the crown. The 20-inch pipe was initially referenced as a 20-inch gas line under DWR levee logs that dated back to 1956. During the 2016 inspection, the pipe was identified (field measured) as an 18-inches non-gas line. It appears that this crossing has been mis-labelled or replaced no additional information was found. [Additional Reference(s): DWR Levee Log, 1956 and 2002] FS Date: 8/11/2016

18-inch abandoned line and 8-inch gas line visible on WS.

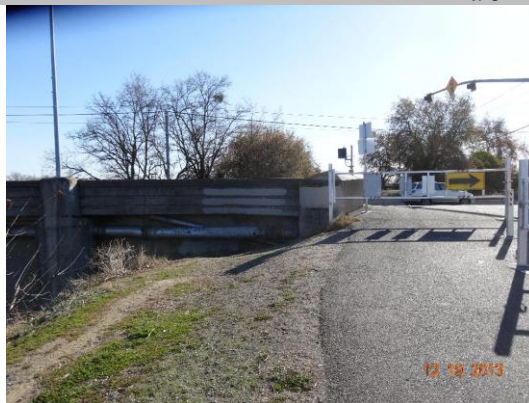
Photo 1 of 3 : UCIP_SP_2017_50050_55422.jpg

LM Start	1.88	Rating **	M	Issue No.	750
LM End	1.88	Issue Type +	En	Location *	WS
Category	Supplemental			GPS Latitude/Longitude	
				Start	End
Item	DWR UCIP Field Study			38.595911 °	38.595911 °
				-121.477485 °	-121.477485 °
DWR ID					
Comment Code					
Inspector Comment					
FS_ID:50050					
DS_ID:24528					
EP_NO: N/A					
Repair Type: Non-Urgent					
Crossing Status: Found					
UCIP Comments: 9/21/2016 According to CVFPB enforcement records.					
PG&E is working on submitting permit for gas line. (DWR UCIP - omagana)					
8/11/2016 gas line is clearly marked on WS. (DWR UCIP - omagana)					
FIELD_STRUCT_DESC: 10-inch steel gas main through the levee, 5 feet below the crown. PG&E label found on WS portion of exposed pipe. Contact for PG&E 1-800-743-6990 or 1-800642-2444. [Additional Reference(s): DWR Levee Log, 2002]					
FS Date: 8/11/2016

Utility lines through levee and across channel.

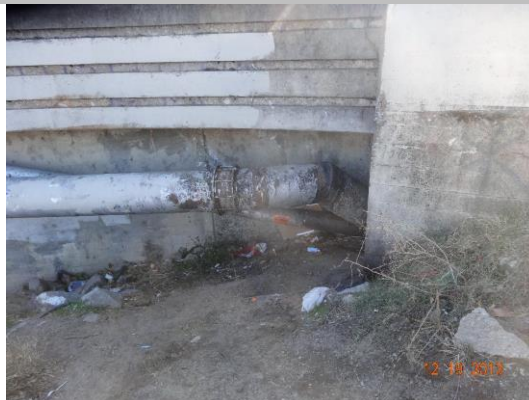
Photo 2 of 3 : UCIP_SP_2017_50050_55421.jpg

Larger line is not marked as gas line and smaller line has label indicating gas line.

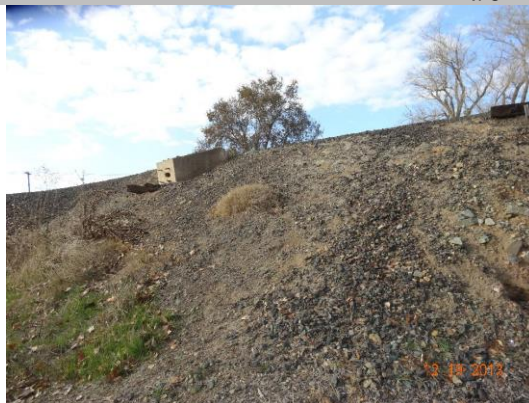
Photo 1 of 3 : UCIP_SP_2017_29927_55259.jpg

LM Start	2.25	Rating **	M	Issue No.	751
LM End	2.25	Issue Type +	En	Location *	LS
Category	Supplemental			GPS Latitude/Longitude	
				Start	End
Item	DWR UCIP Field Study			38.591923 °	38.591923 °
				-121.473744 °	-121.473744 °
DWR ID					
Comment Code					
Inspector Comment					
FS_ID:29927					
DS_ID:24310					
EP_NO: 14150					
Repair Type: Non-Urgent					
Crossing Status: Indicator Found					
UCIP Comments: unable to confirm if crossing is 4-inch steel conduit--will need to coordinate with owner.					
FIELD_STRUCT_DESC: 4-inch steel pipe conduit containing fiber optic cables through the levee, 3.5 feet below the crown. Markers on the levee shoulder. Rock revetment on the waterside (WS) slope. (Permit No. 14150-1986)					
FS Date: 12/19/2013

View of waterward slope--concrete box could be associated with conduit?

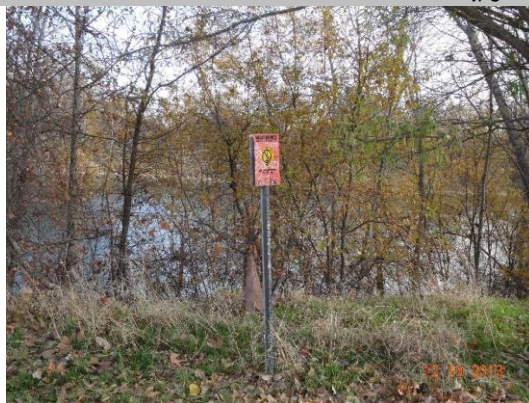
Photo 2 of 3 : UCIP_SP_2017_29927_55261.jpg

Marker for buried fiber optic cable on waterward side.

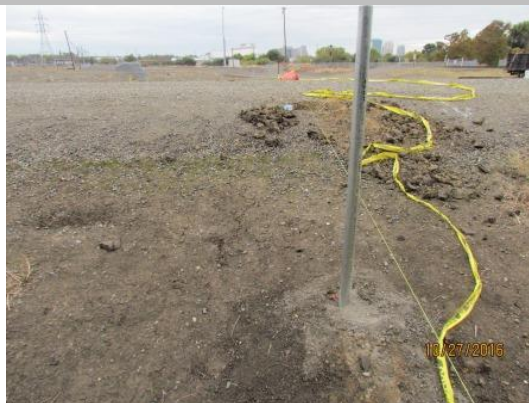
Photo 2 of 4 : SP_2017_NA0001_55_252_20170313_00194.jpg

LM Start	2.28	Rating **	U	Issue No.	252 (cont)
LM End	2.28	Issue Type +	En	Location *	CR

Waterside view of the new fence construction across the levee crown.

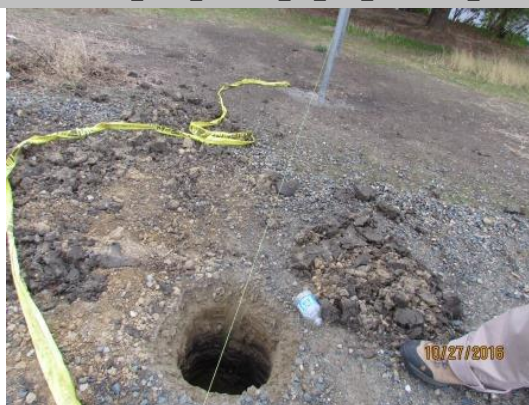
Photo 3 of 4 : SP_2017_NA0001_55_252_20170313_00195.jpg

View of the fence post hole in the levee crown.

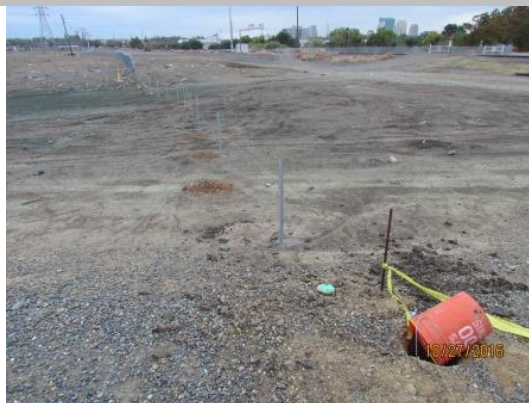
Photo 4 of 4 : SP_2017_NA0001_55_252_20170313_00193.jpg

Landside view of the new fence construction across the levee crown.

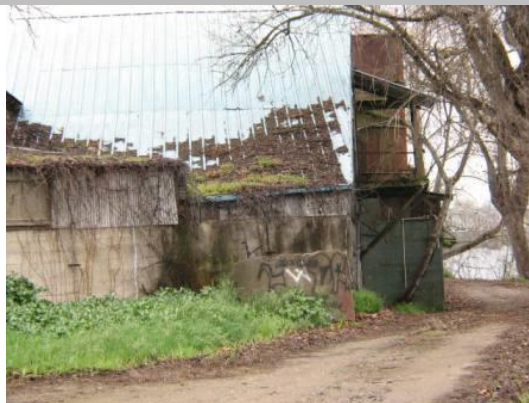
Photo 1 of 1 : SP_2017_NA0001_55_2_20170313_00002.jpg

LM Start	2.68	Rating **	U	Issue No.	2
LM End	2.68	Issue Type +	En	Location *	LS
Category	Earthen Levee			GPS Latitude/Longitude	
				Start	End
Item	Encroachments			38.588913 °	38.588913 °
				-121.467210 °	-121.467210 °
DWR ID	DWR_NA0001_04_s_2012_2				
Comment Code					
BU : Building					
Inspector Comment					
Bell Marine

03/16/2012 Structure on Bell Marine property.

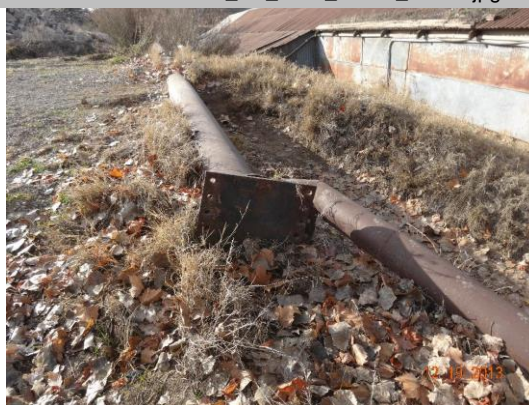
Photo 1 of 2 : UCIP_SP_2017_29944_55267.jpg

Comment Code					
Inspector Comment					
FS_ID:29944 DS_ID:24327 EP_NO: 3362 Repair Type: Non-Urgent Crossing Status: Found UCIP Comments: Pipe sections abandoned on levee crown--need to contact owner to determine status of crossing. FIELD_STRUCT_DESC: 12-inch steel pipe through the levee. Pipe extends from a settling pond, on the left bank berm, to an existing borrow pit located in the overflow area adjacent to the right bank. The pipeline is buried through the top of the riverbanks and buried in the left bank with aggregate revetment placed on the bank. The remainder of the pipeline is exposed across the bottom of the channel and the right bank. The line is used to divert wash water return from the gravel plant to the opposite side of the river. (Permit 8146-1974) FS Date: 12/19/2013

Remnants of old crossing located on levee crown.

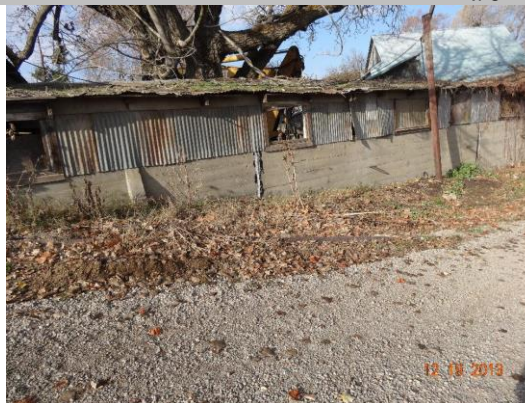
Photo 2 of 2 : UCIP_SP_2017_29944_55266.jpg

View of structure located on levee crown.

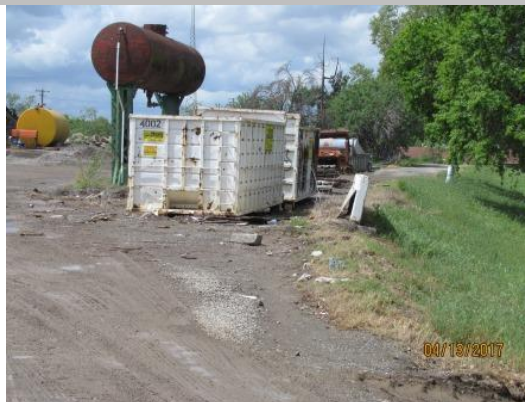
Photo 1 of 2 : SP_2017_NA0001_55_3_20170417_00279.jpg

LM Start	2.72	Rating **	U	Issue No.	3
LM End	2.86	Issue Type +	En	Location *	LS
Category	Earthen Levee			GPS Latitude/Longitude	
				Start	End
Item	Encroachments			38.587939 °	38.587299 °
				-121.466635 °	-121.464320 °
DWR ID	DWR_NA0001_04_s_2012_3				
Comment Code					
EQ : Equipment					
Inspector Comment					
Bell Marine, LMA sent a letter to property owner for the violation. Equipment completely blocks levee crown.

View of the equipment obstructing levee crown access. Spring 2017.

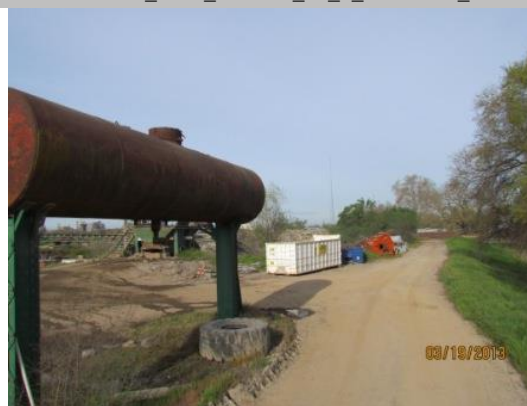
Photo 2 of 2 : SP_2017_NA0001_55_3_20170313_00003.jpg

View of the debris obstructing visibility and access.

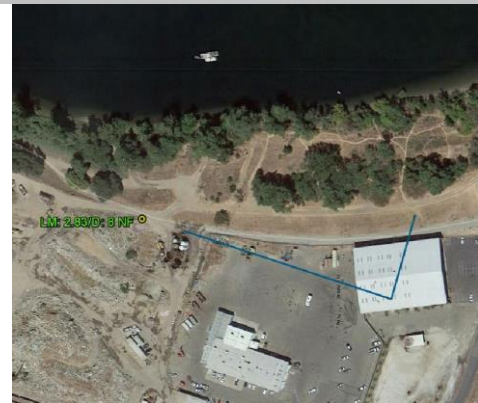
Photo 1 of 1 : UCIP_SP_2017_31253_57216.jpg

Comment Code					
Inspector Comment					
FS_ID:31253 DS_ID:24328 EP_NO: 5890 Repair Type: Non-Urgent Crossing Status: Not Found UCIP Comments: Need to contact owner to determine status of crossing--approximate alignment indicates pipe does not cross levee however records shows drain pipe crosses levee. FIELD_STRUCT_DESC: 8-inch corrugated metal (CM) drainpipe through the levee, 2.1 feet below the crown. Concrete drop inlet structure at waterside (WS) shoulder. Maintenance facilities and yard on the landside (LS). Rock revetment on WS slope. (Pemit No. 5890-1968) This entry matches the Drainage or Irrigation Structure referenced in O&M manual (Station 156+75). FS Date: 12/19/2013

Approximate alignment indicated in blue and approximate location indicated by DWR-UCIP in green label.

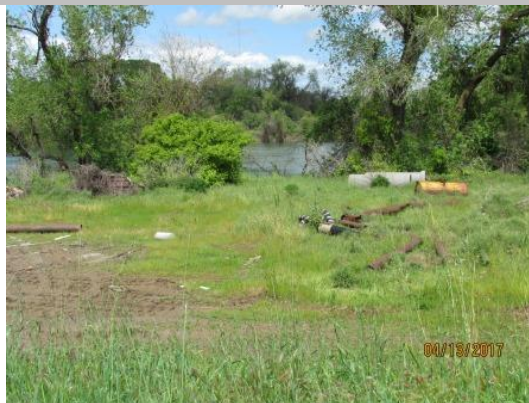
Photo 1 of 3 : SP_2017_NA0001_55_4_20170417_00276.jpg

LM Start	2.83	Rating **	M	Issue No.	4
LM End	2.83	Issue Type +	En	Location *	WS
Category	Earthen Levee			GPS Latitude/Longitude	
				Start	End
Item	Encroachments			38.587272 °	38.587272 °
				-121.464768 °	-121.464768 °
DWR ID	DWR_NA0001_04_s_2012_4				
Comment Code					
DE : Debris					
Inspector Comment					
Bell Marine, LMA sent a letter to the property owner for this violation.

View of the pipes and other debris stored in the floodway.

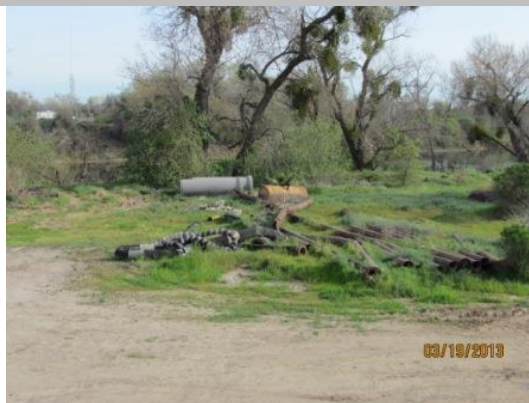
Photo 2 of 3 : SP_2017_NA0001_55_4_20170313_00004.jpg

View of the debris stored in floodway.

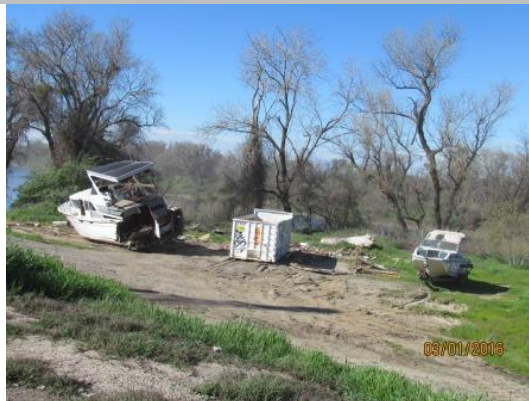
Photo 3 of 3 : SP_2017_NA0001_55_4_20170313_00005.jpg

View of the derelict boats in the floodway. Bell Marine has a service contract to dispose of abandoned boats for the City.

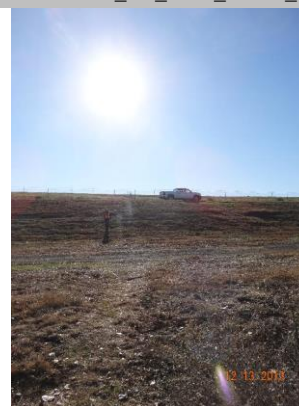
Photo 1 of 3 : UCIP_SP_2017_31254_57217.jpg

Comment Code					
Inspector Comment					
FS_ID:31254 DS_ID:24330 EP_NO: 15041 Repair Type: Non-Urgent Crossing Status: Indicator Found UCIP Comments: Hole present on riser located on landward side--contact owner. Additional pipe found in waterward berm. Unable to confirm if this pipe section is part of crossing--size does not match. Unable to find CM standpipe on waterward side. FIELD_STRUCT_DESC: 16-inch corrugated metal (CM) drainpipe through the levee. Steel cutoff wall around pipe at center of levee. Storm drain gate on landside (LS) shoulder. Drainage ditch on LS. CM standpipe on WS. Rock-filled ditch on WS. (Permit No. 15041-1993) FS Date: 12/13/2013

Overview of waterward side.

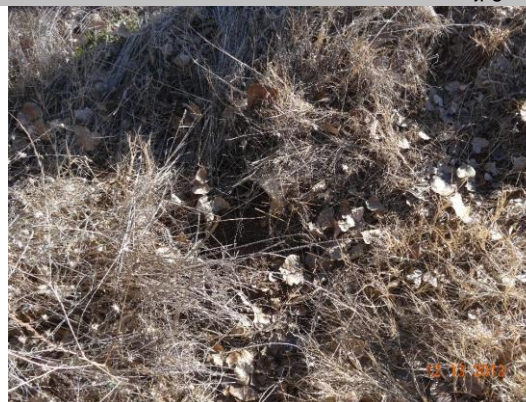
Photo 2 of 3 : UCIP_SP_2017_31254_57219.jpg

Pipe buried by vegetation--unable to determine if pipe goes through levee.

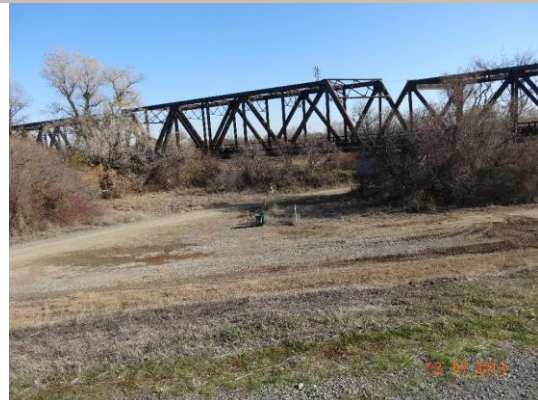
Photo 1 of 3 : UCIP_SP_2017_42128_56573.jpg

Comment Code					
Inspector Comment					
FS_ID:42128 DS_ID:24807 EP_NO: N/A Repair Type: Non-Urgent Crossing Status: Indicator Found UCIP Comments: 11/3/2014 (DWR-Olivia) Need to contact owner to determine status of crossing. Priority under Part IX has been changed from Urgent to Non-Urgent as a measure to normalize the data. Per Title 23 markers are necessary for pressure line--markers present. Recommend LMA to contact owner to determine additional information details--CVFPB permit, depth of pipe through levee, alignment, and last inspection completed confirming integrity of crossing.No permit found. Will need to contact owner to determine the status of crossing. FIELD_STRUCT_DESC: Petroleum pipeline through the levee, unknown depth. Markers visible on waterside (WS). Unable to confirm alignment. Kinder Morgan (Owner) contact information is 916-363-1666. FS Date: 12/13/2013

View of waterward side.

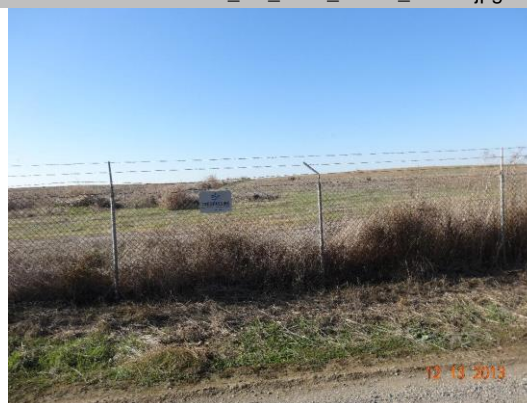
Photo 2 of 3 : UCIP_SP_2017_42128_56572.jpg

Item	DWR UCIP Field Study			38.589033 °	38.589033 °	
				-121.451145 °	-121.451145 °	
DWR ID						
Comment Code						
Inspector Comment						
FS_ID:42128						
DS_ID:24807						
EP_NO: N/A						
Repair Type: Non-Urgent						
Crossing Status: Indicator Found						
UCIP Comments: 11/3/2014 (DWR-Olivia) Need to contact owner to determine status of crossing. Priority under Part IX has been changed from Urgent to Non-Urgent as a measure to normalize the data. Per Title 23 markers are necessary for pressure line--markers present. Recommend LMA to contact owner to determine additional information details--CVFPB permit, depth of pipe through levee, alignment, and last inspection completed confirming integrity of crossing.No permit found. Will need to contact owner to determine the status of crossing.						
FIELD_STRUCT_DESC: Petroleum pipeline through the levee, unknown depth. Markers visible on waterside (WS). Unable to confirm alignment. Kinder Morgan (Owner) contact information is 916-363-1666.

View of landward side.

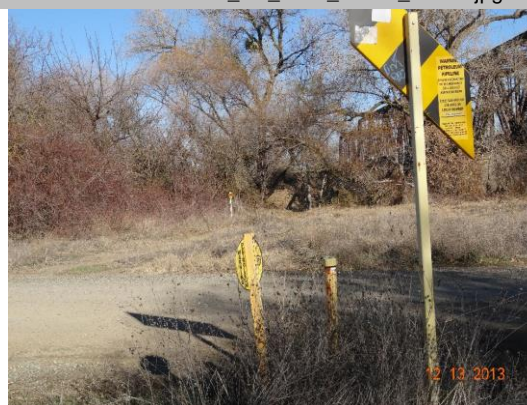
Photo 3 of 3 : UCIP_SP_2017_42128_56576.jpg

View of markers visible on landward side.

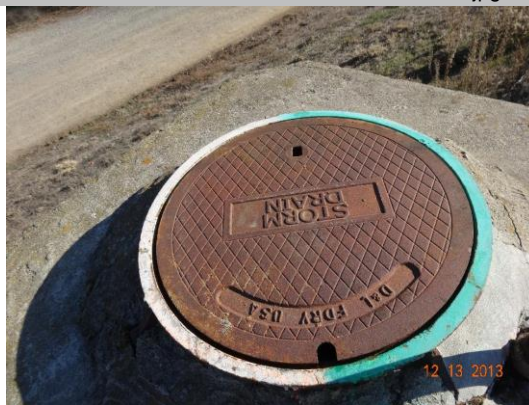
Photo 3 of 3 : UCIP_SP_2017_31255_57222.jpg

Manhole located on waterward slope.

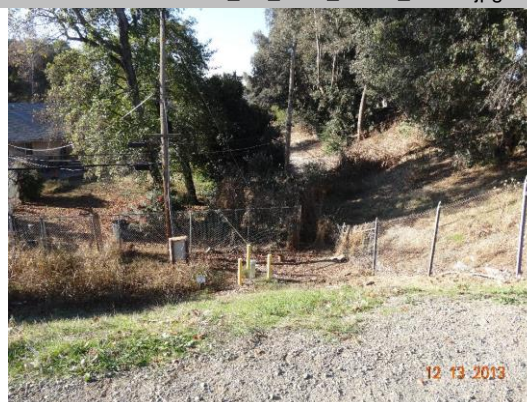
Photo 2 of 3 : UCIP_SP_2017_29054_53587.jpg

View of landward side.

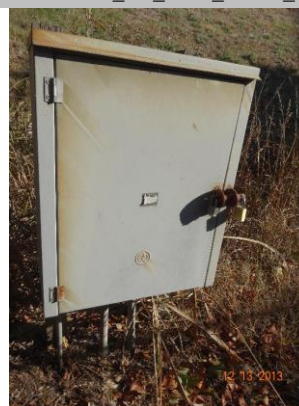
Photo 3 of 3 : UCIP_SP_2017_29054_53589.jpg

Control box located on landward toe.

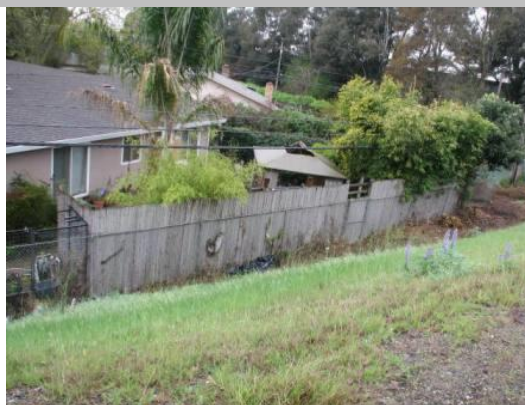
Photo 1 of 2 : SP_2017_NA0001_55_8_20170313_00009.jpg

LM Start	3.90	Rating **	U	Issue No.	8
LM End	3.90	Issue Type +	En	Location *	LS
Category	Earthen Levee			GPS Latitude/Longitude	
				Start	End
Item	Encroachments			38.586327 °	38.586327 °
				-121.447373 °	-121.447373 °
DWR ID	DWR_NA0001_04_s_2012_8				
Comment Code					
FE : Fence					
Inspector Comment					
Bamboo privacy fence within 10-ft of the landside toe obstructs visibility.

03/16/2012 Wood privacy fence completely obstructs access and visibility.

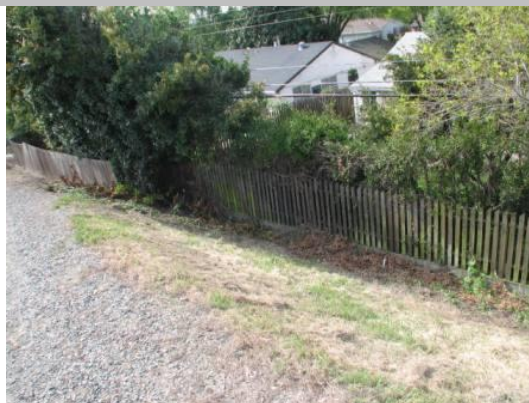
Photo 1 of 1 : SP_2017_NA0001_55_6_20170313_00007.jpg

LM Start	3.92	Rating **	U	Issue No.	6
LM End	3.92	Issue Type +	En	Location *	LS
Category	Earthen Levee			GPS Latitude/Longitude	
				Start	End
Item	Encroachments			38.586154 °	38.586154 °
				-121.447115 °	-121.447115 °
DWR ID	DWR_NA0001_04_s _ 2012_6				
Comment Code					
FE : Fence					
Inspector Comment					
Privacy fence within 10-ft of the landside toe obstructs visibility. 04/14/2011 Landscaping has been removed.

04/14/2011 Landscaping, which was a Fall inspection issue has been removed, however wooden fence is still obstructing access and visibility.

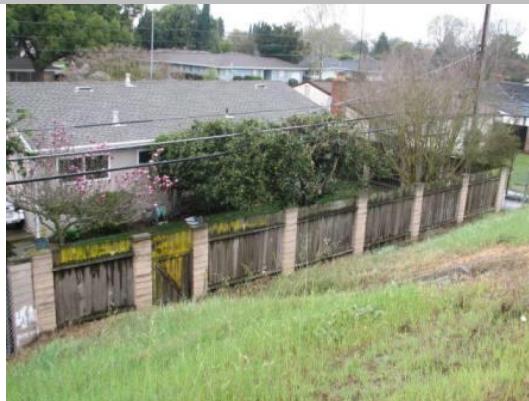
Photo 1 of 1 : SP_2017_NA0001_55_19_20170313_00020.jpg

LM Start	4.09	Rating **	U	Issue No.	19
LM End	4.09	Issue Type +	En	Location *	LS
Category	Earthen Levee			GPS Latitude/Longitude	
				Start	End
Item	Encroachments			38.584459 °	38.584459 °
				-121.444951 °	-121.444951 °
DWR ID	DWR_NA0001_04_s_2012_19				
Comment Code					
FE : Fence					
Inspector Comment					
Privacy fence within 10-ft of the levee toe obstruct access and visibility.

03/16/2012 Wood privacy fence completely obstructs access and visibility.

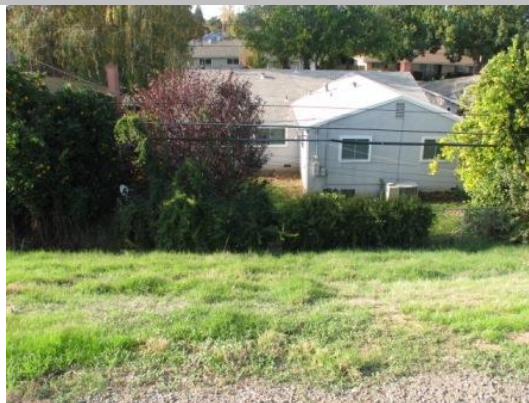
Photo 1 of 1 : SP_2017_NA0001_55_186_20170313_00157.jpg

LM Start	4.10	Rating **	M	Issue No.	186
LM End	4.10	Issue Type +	En	Location *	LS
Category	Earthen Levee			GPS Latitude/Longitude	
				Start	End
Item	Vegetation			38.584354 °	38.584354 °
				-121.444792 °	-121.444792 °
DWR ID	DWR_NA0001_04_s_2012_186				
Comment Code					
V6 : Landscaping					
Inspector Comment					
Landscaping on cyclone fence within 10-ft of levee toe obstructs access and visibility.

Fall 2009 photo: Landscaping within 10-ft of levee toe obstructs access and visibility.

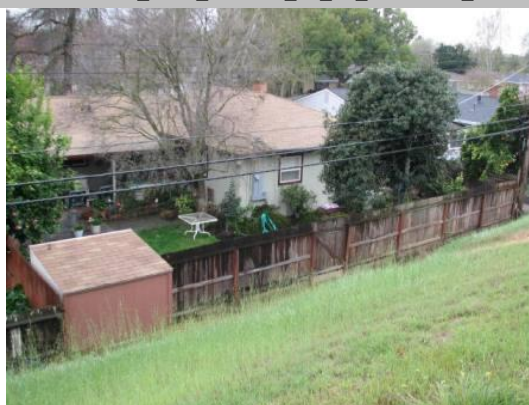
Photo 1 of 1 : SP_2017_NA0001_55_20_20170313_00021.jpg

LM Start	4.11	Rating **	U	Issue No.	20	
LM End	4.11	Issue Type +	En	Location *	LS	
Category	Earthen Levee			GPS Latitude/Longitude		
				Start		End
Item	Encroachments			38.584243 °		38.584243 °
				-121.444647 °		-121.444647 °
DWR ID	DWR_NA0001_04_s_2012_20					
Comment Code						
FE : Fence						
Inspector Comment						
Privacy fence and shed within 10-ft of the levee toe obstruct access and visibility.

03/16/2012 Wood privacy fence completely obstructs access and visibility.

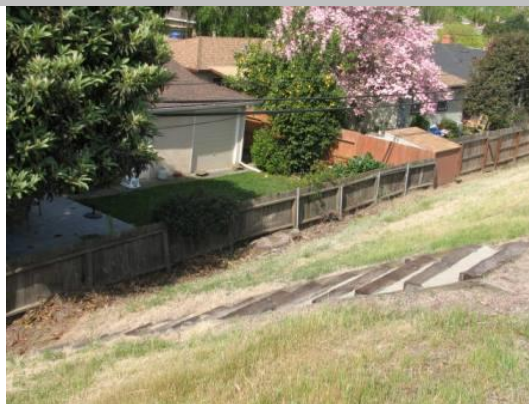
Photo 1 of 1 : SP_2017_NA0001_55_21_20170313_00022.jpg

LM Start	4.12	Rating **	U	Issue No.	21
LM End	4.12	Issue Type +	En	Location *	LS
Category	Earthen Levee			GPS Latitude/Longitude	
				Start	End
Item	Vegetation			38.584129 °	38.584129 °
				-121.444485 °	-121.444485 °
DWR ID	DWR_NA0001_04_s_2012_21				
Comment Code					
V6 : Landscaping					
Inspector Comment					
Palms and other landscaping on levee slope, as well as the wooden privacy fence within 10-ft of the levee toe obstruct access and visibility. 04/14/2011 Palms have been removed.

04/14/2011 Palms have been removed.

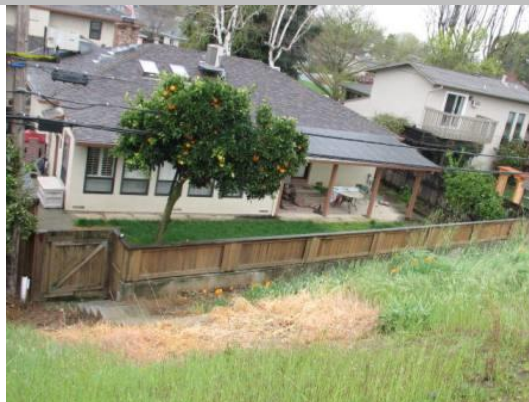
Photo 1 of 1 : SP_2017_NA0001_55_23_20170313_00024.jpg

LM Start	4.14	Rating **	U	Issue No.	23
LM End	4.14	Issue Type +	En	Location *	LS
Category	Earthen Levee			GPS Latitude/Longitude	
				Start	End
Item	Encroachments			38.583935 °	38.583935 °
				-121.444150 °	-121.444150 °
DWR ID	DWR_NA0001_04_s_2012_23				
Comment Code					
FE : Fence					
Inspector Comment					
Cement block and wooden fence obstruct visibility.

03/16/2012 Wooden fence on cement wall obstructs access and visibility.

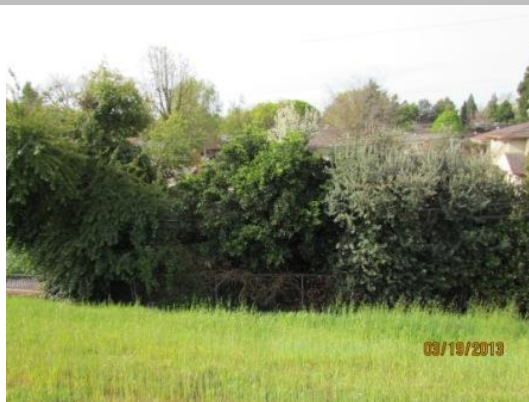
Photo 1 of 1 : SP_2017_NA0001_55_187_20170313_00158.jpg

LM Start	4.15	Rating **	M	Issue No.	187
LM End	4.15	Issue Type +	En	Location *	LS
Category	Earthen Levee			GPS Latitude/Longitude	
				Start	End
Item	Vegetation			38.583858 °	38.583858 °
				-121.443981 °	-121.443981 °
DWR ID	DWR_NA0001_04_s_2012_187				
Comment Code					
V6 : Landscaping					
Inspector Comment					
Orange, guava and other trees and landscaping obstruct access and visibility.

View of the obstructing vegetation at levee toe.

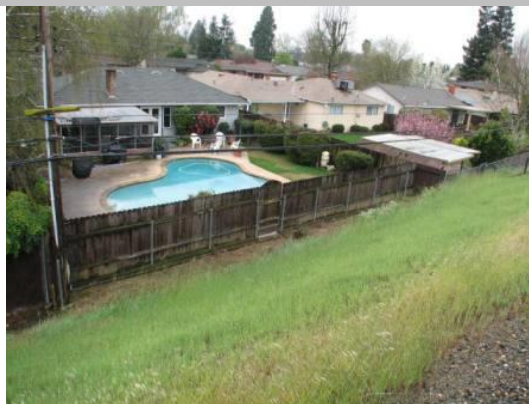
Photo 1 of 1 : SP_2017_NA0001_55_190_20170313_00159.jpg

LM Start	4.19	Rating **	U	Issue No.	190
LM End	4.19	Issue Type +	En	Location *	LS
Category	Earthen Levee			GPS Latitude/Longitude	
				Start	End
Item	Vegetation			38.583559 °	38.583559 °
				-121.443485 °	-121.443485 °
DWR ID	DWR_NA0001_04_s_2012_190				
Comment Code					
V6 : Landscaping					
Inspector Comment					
Planter boxes built into levee slope. Wooden fence obstructs visibility. Pool is just outside 10-ft from levee toe.

03/16/2012 Wood privacy fence completely obstructs access and visibility.

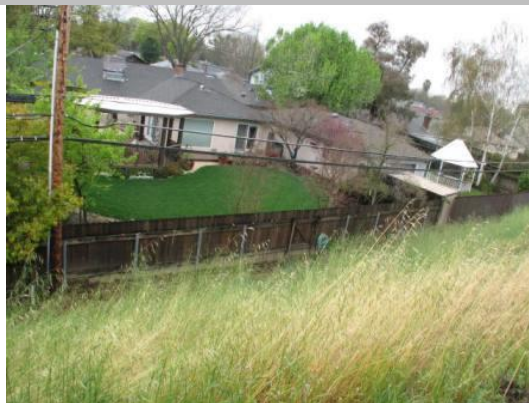
Photo 1 of 1 : SP_2017_NA0001_55_191_20170313_00160.jpg

LM Start	4.21	Rating **	U	Issue No.	191
LM End	4.21	Issue Type +	En	Location *	LS
Category	Earthen Levee			GPS Latitude/Longitude	
				Start	End
Item	Encroachments			38.583355 °	38.583355 °
				-121.443123 °	-121.443123 °
DWR ID	DWR_NA0001_04_s_2012_191				
Comment Code					
FE : Fence					
Inspector Comment					
Wooden privacy fence within 10-ft of the levee toe obstruct access and visibility.

03/16/2012 Wood privacy fence completely obstructs access and visibility.

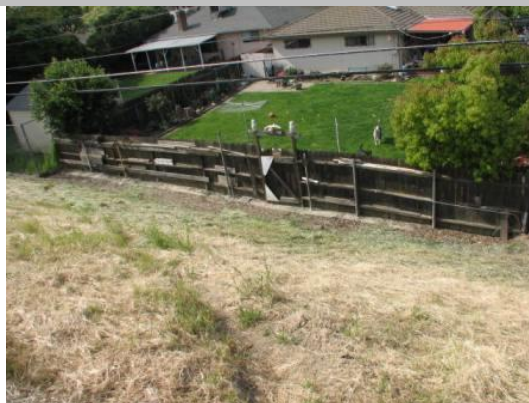
Photo 1 of 1 : SP_2017_NA0001_55_24_20170313_00025.jpg

LM Start	4.22	Rating **	U	Issue No.	24
LM End	4.22	Issue Type +	En	Location *	LS
Category	Earthen Levee			GPS Latitude/Longitude	
				Start	End
Item	Encroachments			38.583265 °	38.583265 °
				-121.442965 °	-121.442965 °
DWR ID	DWR_NA0001_04_s_2012_24				
Comment Code					
FE : Fence					
Inspector Comment					
Wooden privacy fence obstructs visibility. Retaining wall built into levee toe. 04/14/2011 retaining wall removed.

04/14/2011 Retaining wall has been removed. Wooden fence remains and is obstructing access and visibility.

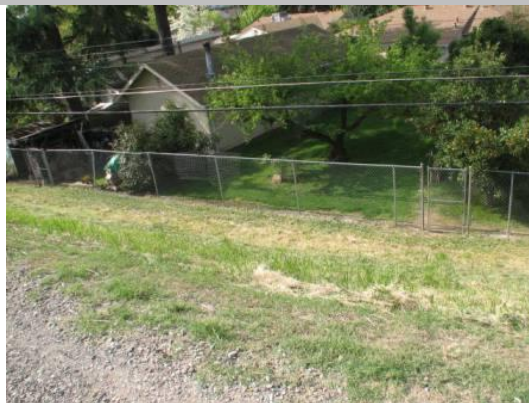
Photo 1 of 1 : SP_2017_NA0001_55_194_20170313_00162.jpg

LM Start	4.28	Rating **	M	Issue No.	194
LM End	4.28	Issue Type +	En	Location *	LS
Category	Earthen Levee			GPS Latitude/Longitude	
				Start	End
Item	Encroachments			38.582716 °	38.582716 °
				-121.442128 °	-121.442128 °
DWR ID	DWR_NA0001_04_s_2012_194				
Comment Code					
FE : Fence					
Inspector Comment					
Planting boxes built into levee slope. 04/14/2011 Planter boxes removed. Chainlink fence partially obstructs access.

04/14/2011 Planter boxes have been removed. Chainlink fence partially blocks access.

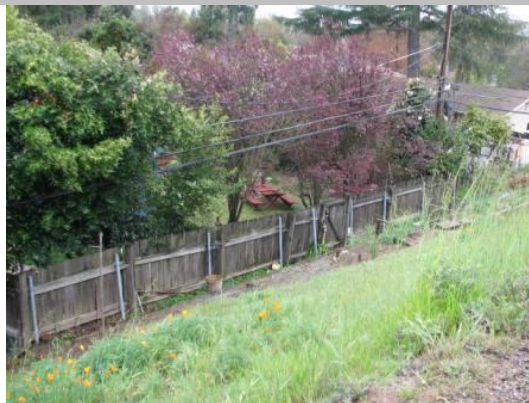
Photo 1 of 1 : SP_2017_NA0001_55_26_20170313_00026.jpg

LM Start	4.31	Rating **	U	Issue No.	26
LM End	4.31	Issue Type +	En	Location *	LS
Category	Earthen Levee			GPS Latitude/Longitude	
				Start	End
Item	Encroachments			38.582479 °	38.582479 °
				-121.441768 °	-121.441768 °
DWR ID	DWR_NA0001_04_s _ 2012_26				
Comment Code					
FE : Fence					
Inspector Comment					
Wooden fence within 10-ft of the levee toe. Garden and ramp built on levee slope.

03/16/2012 Wood privacy fence completely obstructs access and visibility.

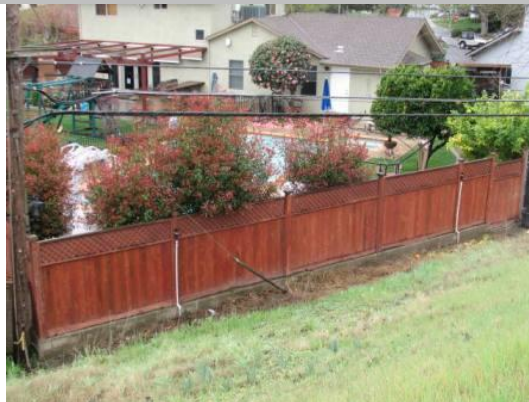
Photo 1 of 1 : SP_2017_NA0001_55_27_20170313_00027.jpg

LM Start	4.34	Rating **	U	Issue No.	27
LM End	4.34	Issue Type +	En	Location *	LS
Category	Earthen Levee			GPS Latitude/Longitude	
				Start	End
Item	Encroachments			38.582223 °	38.582223 °
				-121.441264 °	-121.441264 °
DWR ID	DWR_NA0001_04_s _ 2012_27				
Comment Code					
FE : Fence					
Inspector Comment					
Wooden privacy fence obstructs visibility.

03/16/2012 Wood privacy fence completely obstructs access and visibility.

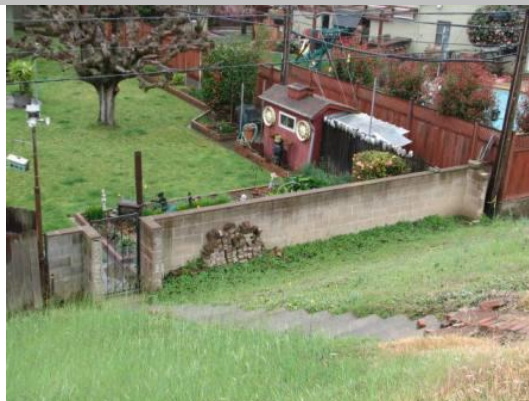
Photo 1 of 1 : SP_2017_NA0001_55_28_20170313_00028.jpg

LM Start	4.35	Rating **	U	Issue No.	28
LM End	4.35	Issue Type +	En	Location *	LS
Category	Earthen Levee			GPS Latitude/Longitude	
				Start	End
Item	Encroachments			38.582186 °	38.582186 °
				-121.441160 °	-121.441160 °
DWR ID	DWR_NA0001_04_s_2012_28				
Comment Code					
FE : Fence					
Inspector Comment					
Cement block fence obstructs access and visibility.

03/16/2012 Cinder block wall obstructs visibility and access.

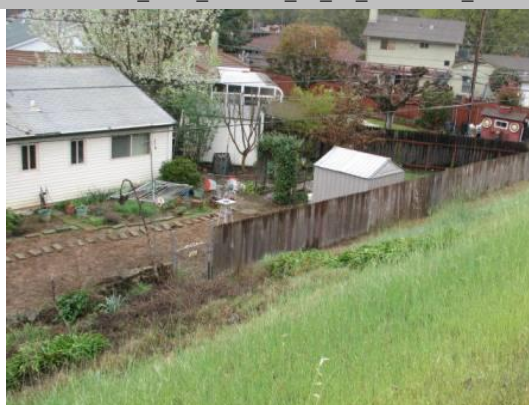
Photo 1 of 1 : SP_2017_NA0001_55_29_20170313_00029.jpg

LM Start	4.36	Rating **	M	Issue No.	29	
LM End	4.36	Issue Type +	En	Location *	LS	
Category	Earthen Levee			GPS Latitude/Longitude		
				Start	End	
Item	Encroachments			38.582083 °	38.582083 °	
				-121.440875 °	-121.440875 °	
DWR ID	DWR_NA0001_04_s_2012_29					
Comment Code						
FE : Fence						
Inspector Comment						
Large flowering bush on levee slope - removed by ARFCD 2012. Retaining wall removed by ARFCD 2012. Wooden fence located at the levee toe obstructs access and visibility. 04/14/2011

03/16/2012 Flowering bush is dormant, landscaping on levee slope and wooden privacy fence.

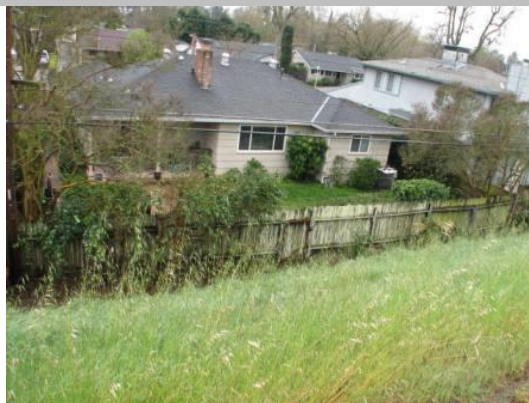
Photo 1 of 1 : SP_2017_NA0001_55_198_20170313_00165.jpg

LM Start	4.41	Rating **	U	Issue No.	198
LM End	4.41	Issue Type +	En	Location *	LS
Category	Earthen Levee			GPS Latitude/Longitude	
				Start	End
Item	Encroachments			38.581788 °	38.581788 °
				-121.440086 °	-121.440086 °
DWR ID	DWR_NA0001_04_s_2012_198				
Comment Code					
FE : Fence					
Inspector Comment					
Privacy fence and landscaping within 10-ft of the levee toe obstruct access and visibility.

03/16/2012 Wood privacy fence completely obstructs access and visibility.

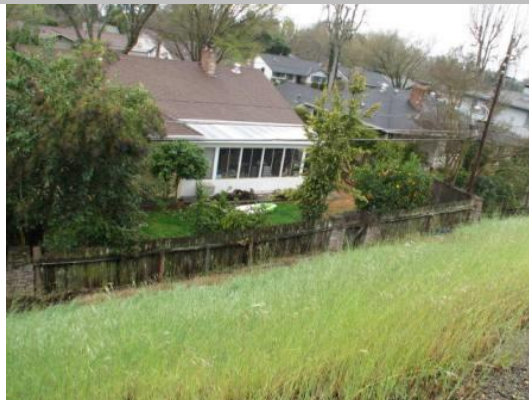
Photo 1 of 1 : SP_2017_NA0001_55_30_20170313_00030.jpg

LM Start	4.42	Rating **	U	Issue No.	30
LM End	4.42	Issue Type +	En	Location *	LS
Category	Earthen Levee			GPS Latitude/Longitude	
				Start	End
Item	Encroachments			38.581724 °	38.581724 °
				-121.439891 °	-121.439891 °
DWR ID	DWR_NA0001_04_s_2012_30				
Comment Code					
FE : Fence					
Inspector Comment					
Privacy fence and landscaping within 10-ft of the levee toe obstruct access and visibility.

03/16/2012 Wood privacy fence completely obstructs access and visibility.

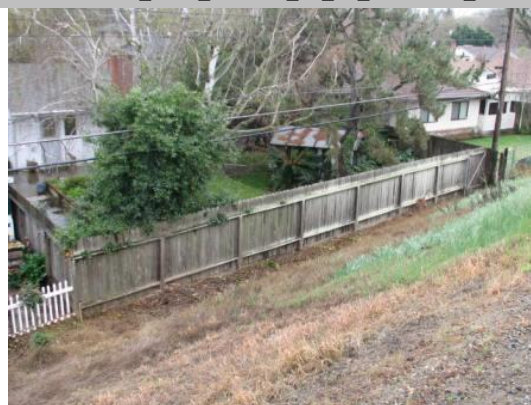
Photo 1 of 1 : SP_2017_NA0001_55_31_20170313_00031.jpg

LM Start	4.47	Rating **	U	Issue No.	31
LM End	4.47	Issue Type +	En	Location *	LS
Category	Earthen Levee			GPS Latitude/Longitude	
				Start	End
Item	Encroachments			38.581495 °	38.581495 °
				-121.439129 °	-121.439129 °
DWR ID	DWR_NA0001_04_s_2012_31				
Comment Code					
FE : Fence					
Inspector Comment					
Privacy fence within 10-ft of the levee toe obstructs access and visibility.

03/16/2012 Wood privacy fence completely obstructs access and visibility.

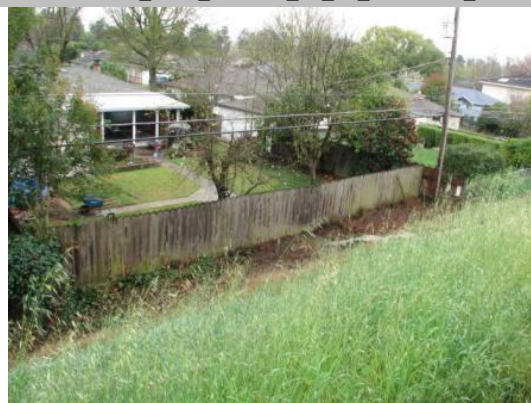
Photo 1 of 1 : SP_2017_NA0001_55_35_20170313_00032.jpg

LM Start	4.53	Rating **	U	Issue No.	35
LM End	4.53	Issue Type +	En	Location *	LS
Category	Earthen Levee			GPS Latitude/Longitude	
				Start	End
Item	Encroachments			38.581246 °	38.581246 °
				-121.438033 °	-121.438033 °
DWR ID	DWR_NA0001_04_s _ 2012_35				
Comment Code					
FE : Fence					
Inspector Comment					
Wooden fence within 10-ft of the levee toe obstructs access and visibility.

03/16/2012 Wood privacy fence completely obstructs access and visibility.

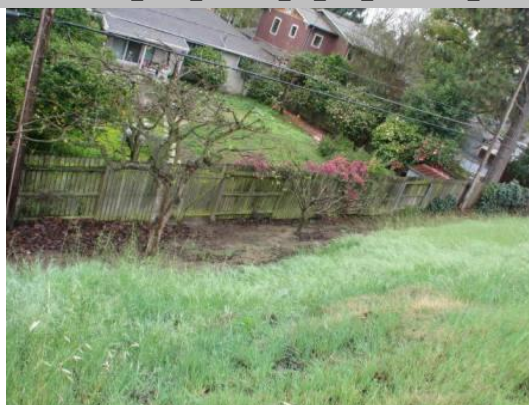
Photo 1 of 1 : SP_2017_NA0001_55_200_20170313_00167.jpg

LM Start	4.55	Rating **	U	Issue No.	200
LM End	4.55	Issue Type +	En	Location *	LS
Category	Earthen Levee			GPS Latitude/Longitude	
				Start	End
Item	Encroachments			38.581178 °	38.581178 °
				-121.437584 °	-121.437584 °
DWR ID	DWR_NA0001_04_s_2012_200				
Comment Code					
FE : Fence					
Inspector Comment					
Privacy fence, persimmon tree and landscaping within 10-ft of the levee toe obstruct access and visibility.

03/16/2012 Wood privacy fence completely obstructs access and visibility.

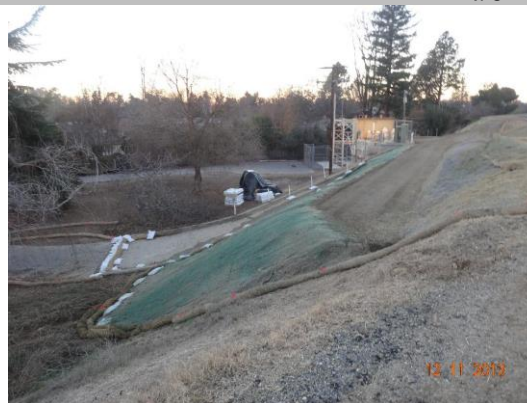
Photo 1 of 3 : UCIP_SP_2017_31446_57490.jpg

LM Start	4.61	Rating **	M	Issue No.	761
LM End	4.61	Issue Type +	En	Location *	LS
Category	Supplemental			GPS Latitude/Longitude	
				Start	End
Item	DWR UCIP Field Study			38.581101 °	38.581101 °
				-121.436502 °	-121.436502 °
DWR ID					
Comment Code					
Inspector Comment					
FS_ID:31446					
DS_ID:24808					
EP_NO: N/A					
Repair Type: Non-Urgent					
Crossing Status: Indicator Found					
UCIP Comments: New construction--need permit and details on crossing.					
FIELD_STRUCT_DESC: 1 of 4: Concrete service box located on waterside (WS) shoulder. Landside (LS) has been regraded. No permit was found for the work. Unable to verify if crossing crosses levee.					
FS Date: 12/13/2013

View of landward side.

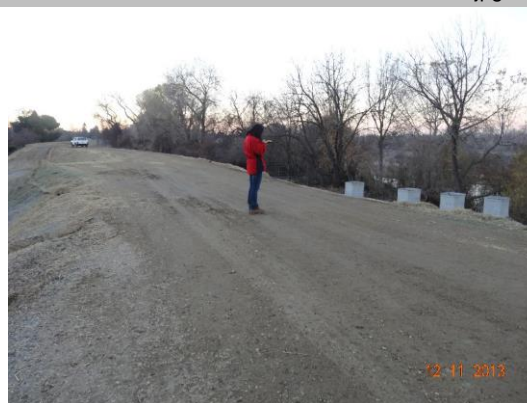
Photo 2 of 3 : UCIP_SP_2017_31446_57489.jpg

View of regraded levee crown with service boxes on waterward slope.

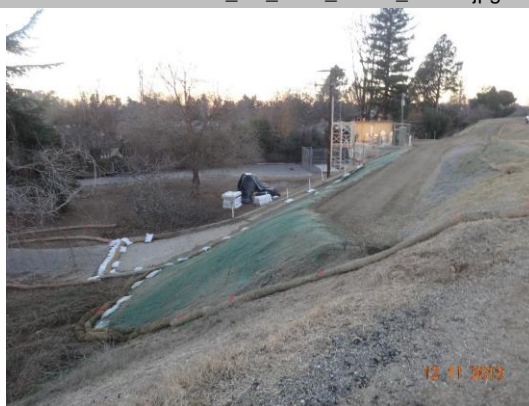
Photo 1 of 3 : UCIP_SP_2017_31448_57496.jpg

LM Start	4.61	Rating **	M	Issue No.	763
LM End	4.61	Issue Type +	En	Location *	LS
Category	Supplemental			GPS Latitude/Longitude	
				Start	End
Item	DWR UCIP Field Study			38.581087 °	38.581087 °
				-121.436449 °	-121.436449 °
DWR ID					
Comment Code					
Inspector Comment					
FS_ID:31448					
DS_ID:24810					
EP_NO: N/A					
Repair Type: Non-Urgent					
Crossing Status: Indicator Found					
UCIP Comments: New construction; no permit found; Need additional information about crossings to determine whether crossings penetrate levee.					
FIELD_STRUCT_DESC: 3 of 4: Concrete service box located on waterside (WS) shoulder. Landside (LS) has been regraded. No permit was found for the work. Unable to verify if crossing crosses levee.					
FS Date: 12/13/2013

View of landward side.

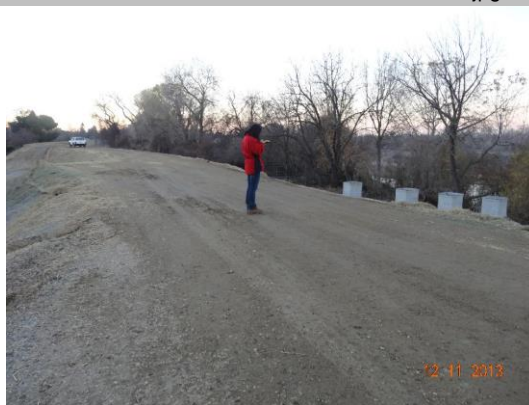
Photo 2 of 3 : UCIP_SP_2017_31448_57495.jpg

View of levee crown.

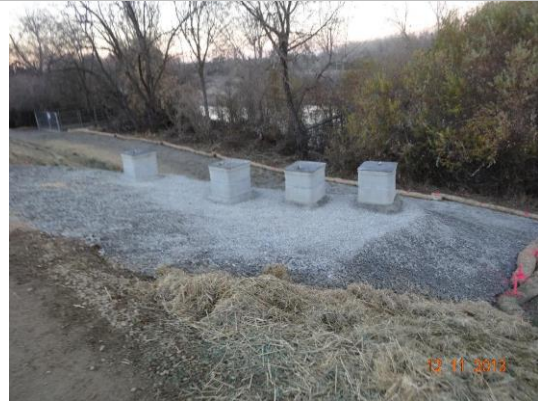
Photo 3 of 3 : UCIP_SP_2017_31448_57494.jpg

LM Start	4.61	Rating **	M	Issue No.	763 (cont)	
LM End	4.61	Issue Type +	En	Location *	LS	
Category	Supplemental			GPS Latitude/Longitude		
				Start		End
Item	DWR UCIP Field Study			38.581087 °		38.581087 °
				-121.436449 °		-121.436449 °
DWR ID						
Comment Code						
Inspector Comment						
FS_ID:31448 DS_ID:24810 EP_NO: N/A Repair Type: Non-Urgent Crossing Status: Indicator Found UCIP Comments: New construction; no permit found; Need additional information about crossings to determine whether crossings penetrate levee. FIELD_STRUCT_DESC: 3 of 4: Concrete service box located on waterside (WS) shoulder. Landside (LS) has been regraded. No permit was found for the work. Unable to verify if crossing crosses levee. FS Date: 12/13/2013

View of waterward side.

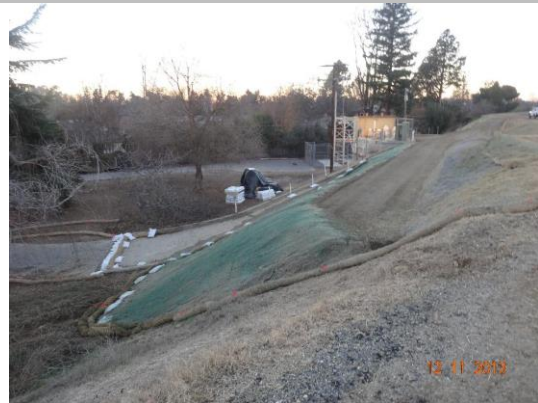
Photo 1 of 3 : UCIP_SP_2017_31449_57499.jpg

LM Start	4.61	Rating **	M	Issue No.	764
LM End	4.61	Issue Type +	En	Location *	LS
Category	Supplemental			GPS Latitude/Longitude	
				Start	End
Item	DWR UCIP Field Study			38.581082 °	38.581082 °
				-121.436431 °	-121.436431 °
DWR ID					
Comment Code					
Inspector Comment					
FS_ID:31449					
DS_ID:24811					
EP_NO: N/A					
Repair Type: Non-Urgent					
Crossing Status: Indicator Found					
UCIP Comments: New construction; no permit found; Need additional information about crossings to determine whether crossing penetrate levee.					
FIELD_STRUCT_DESC: 4 of 4: Concrete service box located on waterside (WS) shoulder. Landside (LS) has been regraded. No permit was found for the work. Unable to verify if crossing crosses levee.					
FS Date: 12/13/2013

View of landward side.

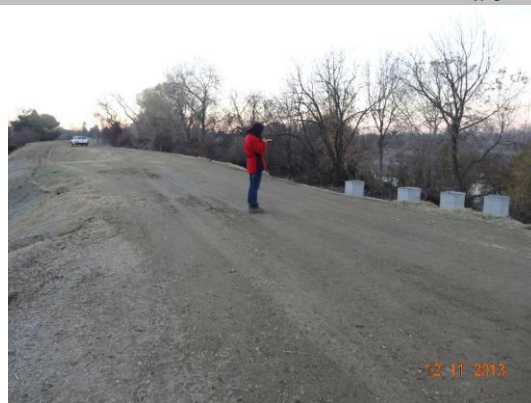
Photo 2 of 3 : UCIP_SP_2017_31449_57498.jpg

LM Start	4.61	Rating **	M	Issue No.	764 (cont)	
LM End	4.61	Issue Type +	En	Location *	LS	
Category	Supplemental			GPS Latitude/Longitude		
				Start	End	
Item	DWR UCIP Field Study			38.581082 °	38.581082 °	
				-121.436431 °	-121.436431 °	
DWR ID						
Comment Code						
Inspector Comment						
FS_ID:31449						
DS_ID:24811						
EP_NO: N/A						
Repair Type: Non-Urgent						
Crossing Status: Indicator Found						
UCIP Comments: New construction; no permit found; Need additional information about crossings to determine whether crossing penetrate levee.						
FIELD_STRUCT_DESC: 4 of 4: Concrete service box located on waterside (WS) shoulder. Landside (LS) has been regraded. No permit was found for the work. Unable to verify if crossing crosses levee.						
FS Date: 12/13/2013

View of levee crown.

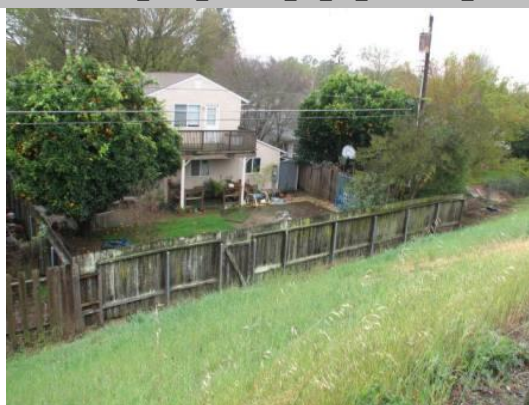
Photo 1 of 1 : SP_2017_NA0001_55_40_20170313_00033.jpg

LM Start	4.73	Rating **	U	Issue No.	40
LM End	4.73	Issue Type +	En	Location *	LS
Category	Earthen Levee			GPS Latitude/Longitude	
				Start	End
Item	Encroachments			38.580759 °	38.580759 °
				-121.434294 °	-121.434294 °
DWR ID	DWR_NA0001_04_s_2012_40				
Comment Code					
FE : Fence					
Inspector Comment					
Privacy fence within 10-ft of the levee toe obstruct access and visibility.

03/16/2012 Wood privacy fence completely obstructs access and visibility.

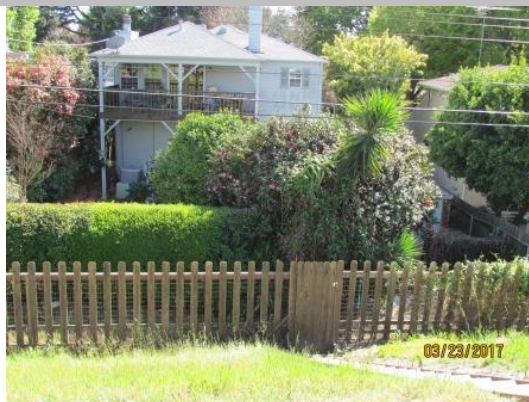
Photo 1 of 1 : SP_2017_NA0001_55_41_20170406_00275.jpg

LM Start	4.74	Rating **	M	Issue No.	41
LM End	4.74	Issue Type +	En	Location *	LS
Category	Earthen Levee			GPS Latitude/Longitude	
				Start	End
Item	Encroachments			38.580753 °	38.580753 °
				-121.434077 °	-121.434077 °
DWR ID	DWR_NA0001_04_s_2012_41				
Comment Code					
FE : Fence					
Inspector Comment					
Privacy fence and landscaping within 10-ft of the levee toe obstruct access and visibility.

View of the fence at the levee toe.

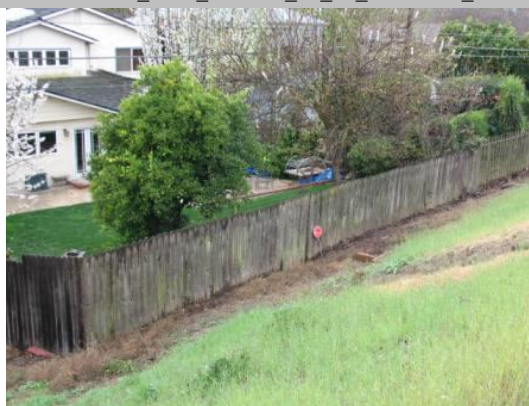
Photo 1 of 1 : SP_2017_NA0001_55_42_20170313_00034.jpg

LM Start	4.76	Rating **	U	Issue No.	42
LM End	4.76	Issue Type +	En	Location *	LS
Category	Earthen Levee			GPS Latitude/Longitude	
				Start	End
Item	Encroachments			38.580744 °	38.580744 °
				-121.433868 °	-121.433868 °
DWR ID	DWR_NA0001_04_s _ 2012_42				
Comment Code					
FE : Fence					
Inspector Comment					
Privacy fence within 10-ft of the levee toe obstruct access and visibility.

03/16/2012 Wood privacy fence completely obstructs access and visibility.

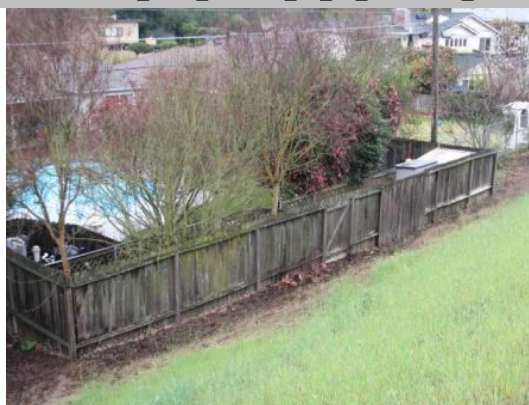
Photo 1 of 1 : SP_2017_NA0001_55_43_20170313_00035.jpg

LM Start	4.78	Rating **	U	Issue No.	43
LM End	4.78	Issue Type +	En	Location *	LS
Category	Earthen Levee			GPS Latitude/Longitude	
				Start	End
Item	Encroachments			38.580731 °	38.580731 °
				-121.433490 °	-121.433490 °
DWR ID	DWR_NA0001_04_s _ 2012_43				
Comment Code					
FE : Fence					
Inspector Comment					
Privacy fence and storage sheds within 10-ft of the levee toe obstruct access and visibility.

03/16/2012 Wood privacy fence completely obstructs access and visibility.

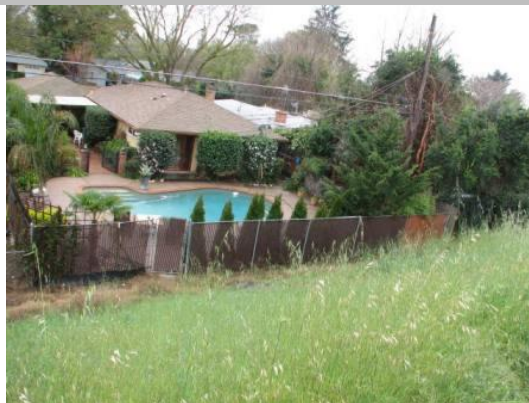
Photo 1 of 1 : SP_2017_NA0001_55_205_20170313_00169.jpg

LM Start	4.83	Rating **	U	Issue No.	205
LM End	4.83	Issue Type +	En	Location *	LS
Category	Earthen Levee			GPS Latitude/Longitude	
				Start	End
Item	Encroachments			38.580723 °	38.580723 °
				-121.432577 °	-121.432577 °
DWR ID	DWR_NA0001_04_s _ 2012_205				
Comment Code					
FE : Fence					
Inspector Comment					
Privacy fence and landscape prunings on levee slope and toe.prunings removed. Fence obstructs access and visibility.

03/16/2012 Chainlink fence with privacy slats obstructs visibility and access.

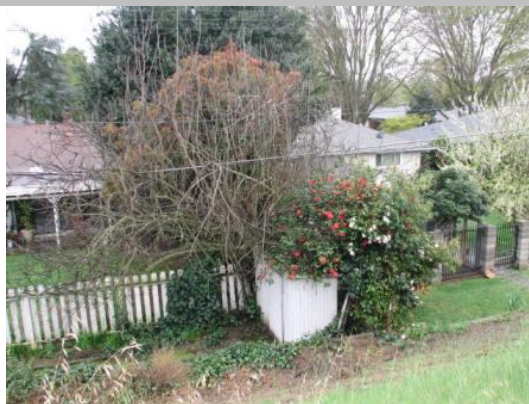
Photo 1 of 1 : SP_2017_NA0001_55_206_20170313_00170.jpg

LM Start	4.87	Rating **	U	Issue No.	206
LM End	4.87	Issue Type +	En	Location *	LS
Category	Earthen Levee			GPS Latitude/Longitude	
				Start	End
Item	Vegetation			38.580778 °	38.580778 °
				-121.431704 °	-121.431704 °
DWR ID	DWR_NA0001_04_s _ 2012_206				
Comment Code					
V6 : Landscaping					
Inspector Comment					
Fig tree obstructs visibility and access.

03/16/2012 Landscaping obstructs visibility and access.

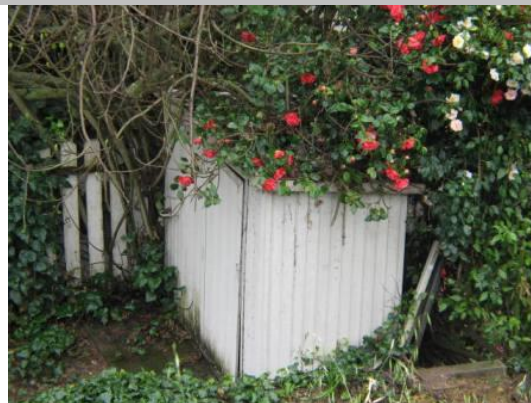
Photo 1 of 1 : SP_2017_NA0001_55_96_20170313_00080.jpg

LM Start	4.87	Rating **	U	Issue No.	96
LM End	4.87	Issue Type +	En	Location *	LS
Category	Earthen Levee			GPS Latitude/Longitude	
				Start	End
Item	Encroachments			38.580767 °	38.580767 °
				-121.431684 °	-121.431684 °
DWR ID	DWR_NA0001_04_s _ 2012_96				
Comment Code					
BU : Building					
Inspector Comment					
Wooden shed is located beneath the fig tree.

3/16/2012 Structure is within 15' of levee toe.

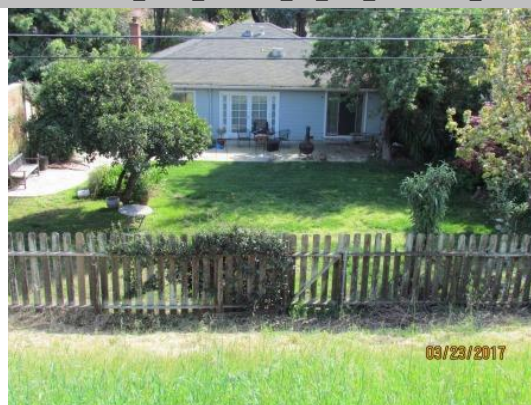
Photo 1 of 1 : SP_2017_NA0001_55_265_20170406_00274.jpg

LM Start	4.89	Rating **	M	Issue No.	265
LM End	4.89	Issue Type +	En	Location *	LS
Category	Earthen Levee			GPS Latitude/Longitude	
				Start	End
Item	Encroachments			38.580794 °	38.580794 °
				-121.431453 °	-121.431453 °
DWR ID	DWR_NA0001_04_s _ 2017_265				
Comment Code					
FE : Fence					
Inspector Comment					
Fence at levee toe.

View of the fence at the levee toe.
